# Windstorm Mitigation Affidavit Report

Tyrone Fifth Avenue Apartments Condominium  
Bldg A, 5924 5th Ave, Units 1-12  
St. Petersburg, FL 33710

Prepared Exclusively for Tyrone Fifth Avenue Apartments Condominium Association, Inc.  
As of 07-30-2026 | FPAT File# MUD2623808

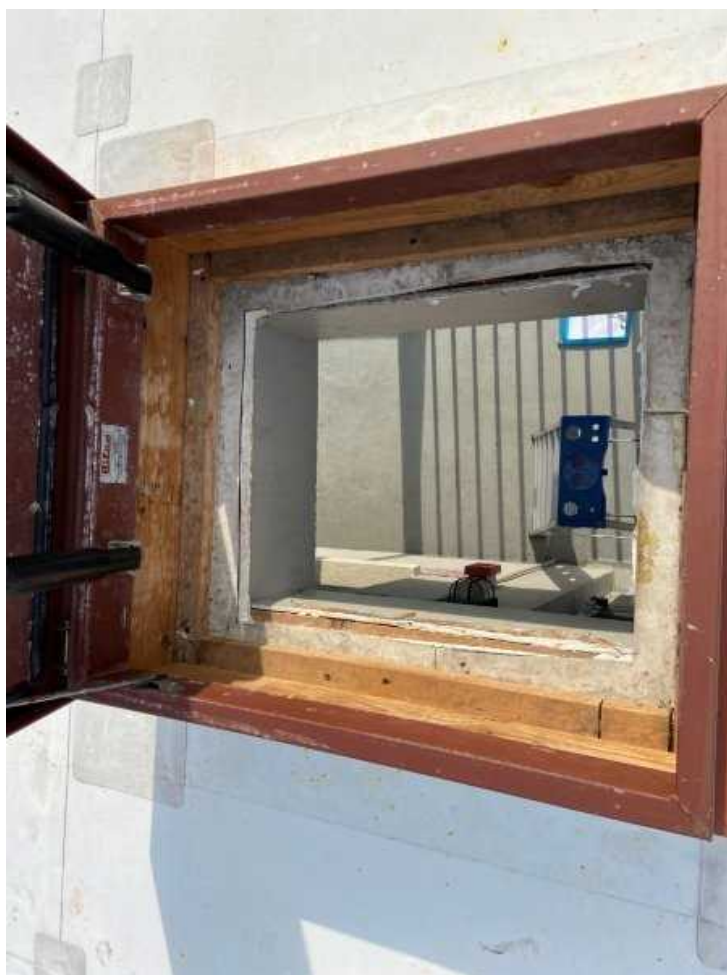
Roof Permit Information

| <b>4. Roof Covering:</b><br>Comments: | <b>A. FBC Equivalent</b><br>The roof covering was replaced in 2025. The roof permit was confirmed and the permit number is 25-7001036. This roof was verified as meeting the building code requirements outlined on the mitigation affidavit. |

| Structure Detail | | | |
|---|---|---|---|
| Application #: | 25 - 7001036 | Application Type: | ROOF REPLACEMENT RESIDENTIAL OVER 40 SQUARES |
| PITCH/SLOPE | | 4/12 | |
| ROOF TYPE | | TPO | |

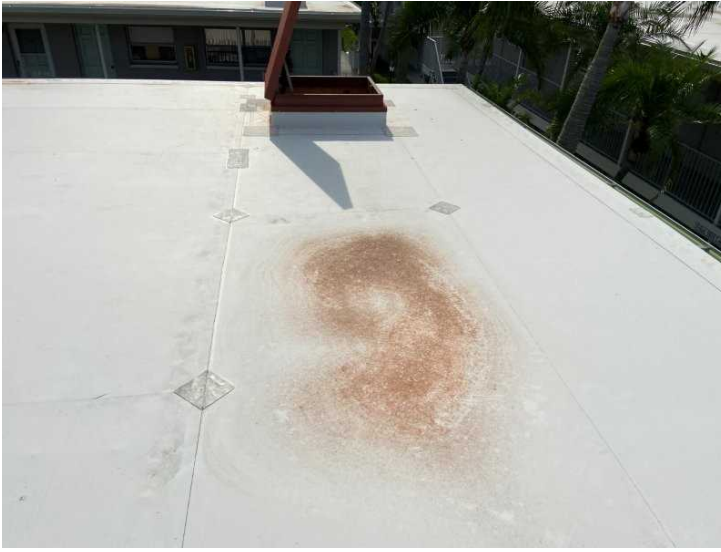
Roof Construction

| <b>7. Roof Geometry:</b><br>Comments: | <b>B. Flat Roof</b><br>Inspection verified flat roof shape, refer to attached photographs. |
