# Windstorm Mitigation Affidavit Report

Tyrone Fifth Avenue Apartments Condominium  
Bldg B, 5916 5th Ave, Units 1-12  
St. Petersburg, FL 33710

Prepared Exclusively for Tyrone Fifth Avenue Apartments Condominium Association, Inc.  
As of 07-30-2026 | FPAT File# MUD2623808

### For Bldg B, 5916 5th Ave, Units 1-12

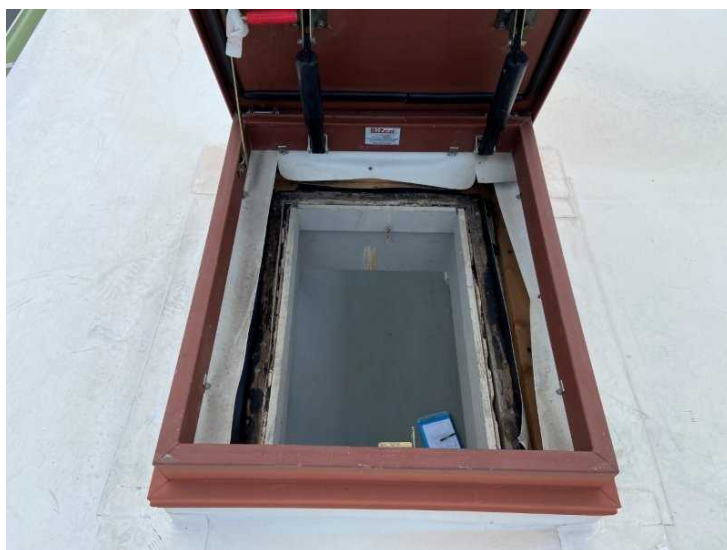
Roof Construction

| <b>7. Roof Geometry:</b><br>Comments: | <b>B. Flat Roof</b><br>Inspection verified flat roof shape, refer to attached photographs. |
