# Windstorm Mitigation Affidavit Report

Tyrone Fifth Avenue Apartments Condominium  
Bldg C, 5908 5th Ave, Units 1-10, C2-C3  
St. Petersburg, FL 33710

Prepared Exclusively for Tyrone Fifth Avenue Apartments Condominium Association, Inc.  
As of 07-30-2026 | FPAT File# MUD2623808

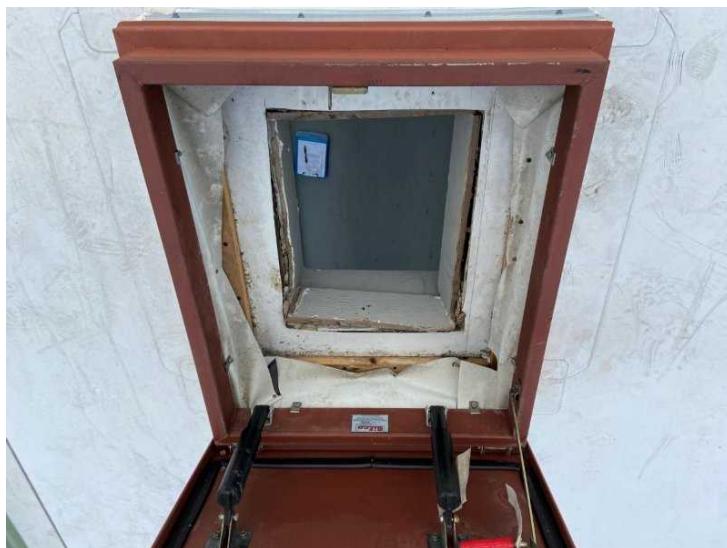
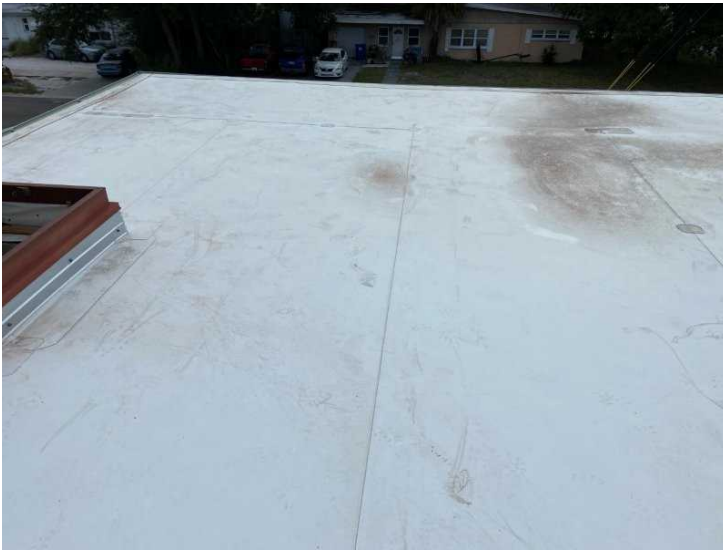
Roof Construction

| <b>7. Roof Geometry:</b><br>Comments: | <b>B. Flat Roof</b><br>Inspection verified flat roof shape, refer to attached photographs. |
