# Windstorm Mitigation Affidavit Report

Tyrone Fifth Avenue Apartments Condominium  
Bldg D, 5900 5th Ave, Units 1-10, D6-D7  
St. Petersburg, FL 33710

Prepared Exclusively for Tyrone Fifth Avenue Apartments Condominium Association, Inc.  
As of 07-30-2026 | FPAT File# MUD2623808

## RECAPITULATION OF MITIGATION FEATURES

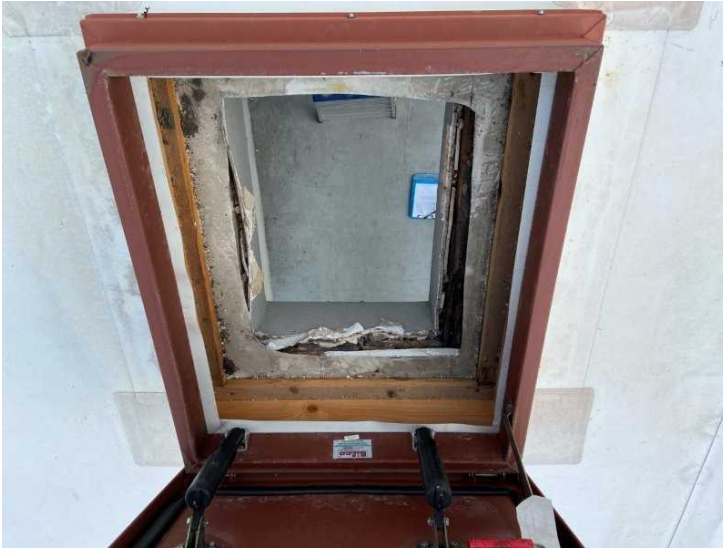
Roof Construction

| <b>7. Roof Geometry:</b><br>Comments: | <b>B. Flat Roof</b><br>Inspection verified flat roof shape, refer to attached photographs. |
